CONESTOGA TELEVISION ASSOCIATION
Lancaster, Pennsylvania

Technical Report

TELEVISION RECEPTION FROM W3XBR - SUMMER 1948

September 13, 1948

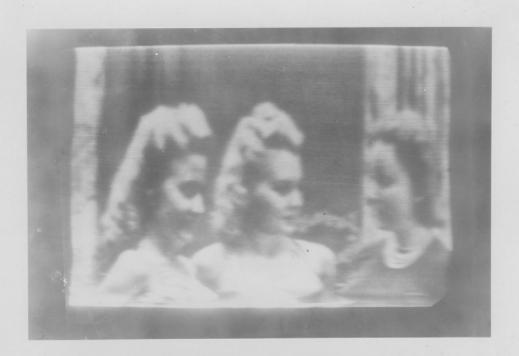
Photograph of Picture Received at the Penthouse

This picture shows noise intermediate between Hoffmann's and Richards' locations. Hoise may be noted on the background. Several frames were required to expose the film so noise is somewhat integrated out. Here again the true character of the noise is not well presented by the photograph. Conditions such as vertical linearity were not considered in arranging for this photograph.

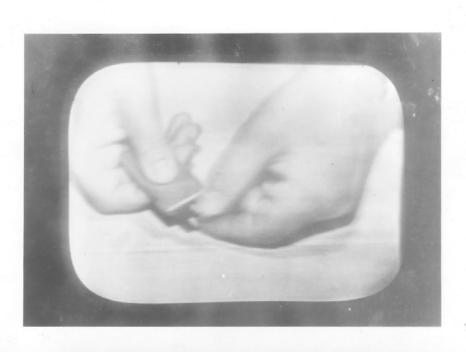
Photograph of Picture Received at Hoffmann's Residence

Exposure time of a few frames was used to give a true indication of noise. Observers of this picture insist that the photograph does not do the televised picture justice.

The new transmitter was used (Report No. 54).

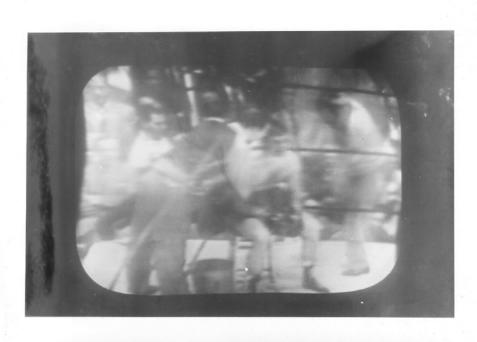
Photograph of Picture Received at Hoffmann's Residence

Exposure of only a few frames was used.

Motion of the persons helps to obscure contours. The picture appeared better to the observer than does this photograph.

This was taken while the large transmitter (Report No. 54) was being tested.
